# Fourth International Conference on Forensic Engineering

## **PERFORMANCE OF ROOF SYSTEMS DURING THE 2004 AND 2005 HURRICANES IN SOUTH FLORIDA**

# Performance of Roof Systems during the 2004 and 2005 Hurricanes in South Florida

**Gregory S. McLellan, P.E., M.ASCE, Alex Puig, P.E., Maria Cordovez, P.E.**  
The Pepper Engineering Group, Miami, USA

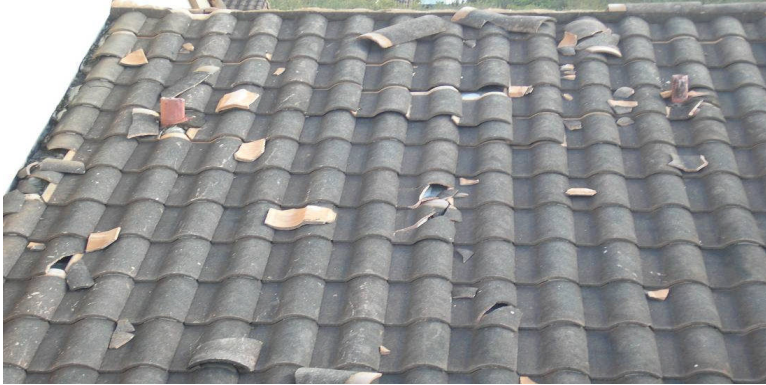
One of the residences used in this study was located in the Miami, Florida area. The house is a 2-story single family home with a mortar set concrete tile roof system over a plywood roof deck and wood roof trusses. This house was built in 1991 and the roof was original. During our damaged assessment for the Hurricane Wilma we found several broken, missing and dislodged field tiles. The damage to these tiles was generally consistent with wind damage. The observed repairs needed because of the wind damage in this case exceeded 25% of the total roof area. (Photo 1)

Photo 1: Mortar set roof system, with wind damage over 25%.

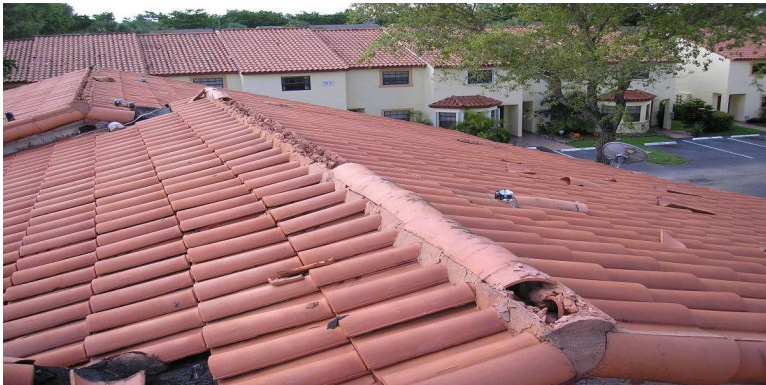
The second residence is a 2-story single family home located in Broward County, also with a concrete tile roof system over a plywood roof deck and wood roof trusses. The ridge tiles were installed with mortar and the field tiles were installed with a foam-type structural adhesive. This roof was installed in 2000. We found a few broken field tiles and numerous missing ridge tiles. The damage to the field tiles appeared to be the result of impact from the dislodged ridge tiles. The observed repairs needed because of the wind damage in this case were approximately 3% of the total roof area. (Photo 2)

Photo 2: Foam set roof system with scattered roof ridge tiles and minimal wind damage to the field tiles. (Ridge tiles installed with mortar only.)

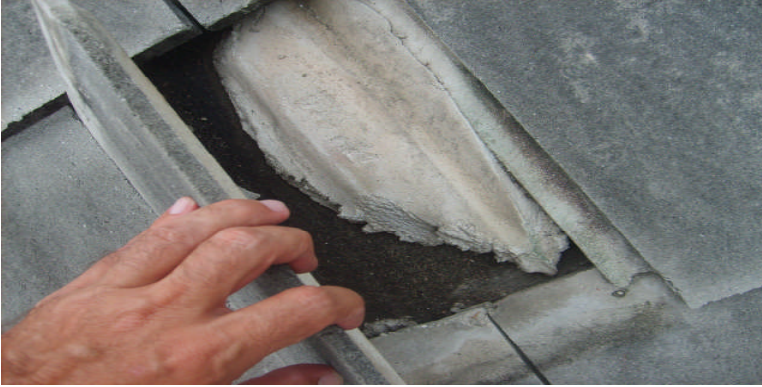
The conditions observed in the residences above were the typical conditions observed in most of the inspected residences. During our inspections we found many of the mortar-set field tiles, mainly on the roofs installed prior to the code modifications in the 1996 SFBC, were loose throughout the roof area. The loose tiles were in place and had not been dislodged or otherwise damaged. The failure plane was between the tiles and the mortar. (Photo 3) The condition of mortar-set roof tiles being loose in place with the bond failure plane between the tile and the mortar is not consistent with damage caused by wind forces. It is our opinion that wind does not gently pry roof tiles loose from their mortar paddies and leave them in place and not otherwise visibly damaged.

Photo 3: Loose tiles in place with the failure plane between the tiles and the mortar.

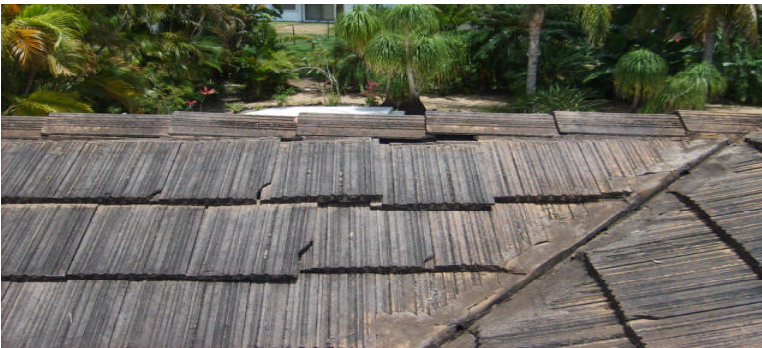
The first residence is a 2-story single family home located in the Broward County with a nailed down concrete tile roof system over a plywood roof deck and wood roof trusses. This house was built in 1991. During our post damaged assessment for the Hurricane Wilma we found missing and dislodged ridge tiles and several tiles with new cracks across their lower corners. Cracks of this nature can be caused by fluttering of the tiles under wind pressure. The observed repairs needed because of the wind damage in this case were approximately 15% of the total roof area. (Photo 4)

Photo 4: Nail down roof tiles with wind damage to the field tiles.

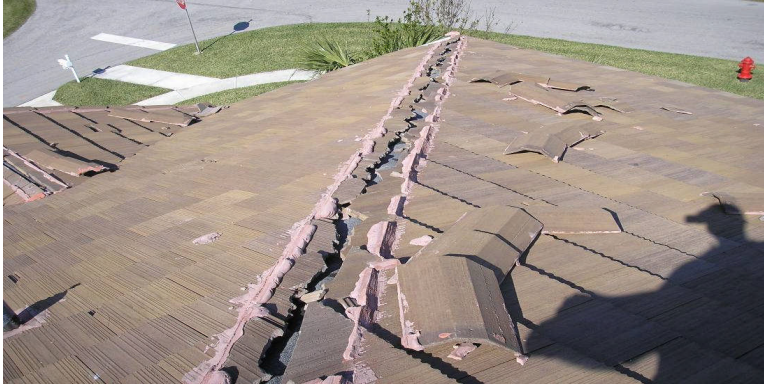
The second residence used in this study was located in the Broward County. The house is a 2-story single family home with a nailed down concrete tile roof system over a plywood roof deck and wood roof trusses. This house was built in 1997. During our post damaged assessment for the Hurricane Wilma we found a few missing and dislodged ridge and rake tiles. The damage to these tiles was generally consistent with wind damage. The observed repairs needed because of the wind damage in this case was approximately 5% of the total roof area. (Photo 5)

Photo 5: Nail down roof tiles with minimal wind damage to the field tiles.

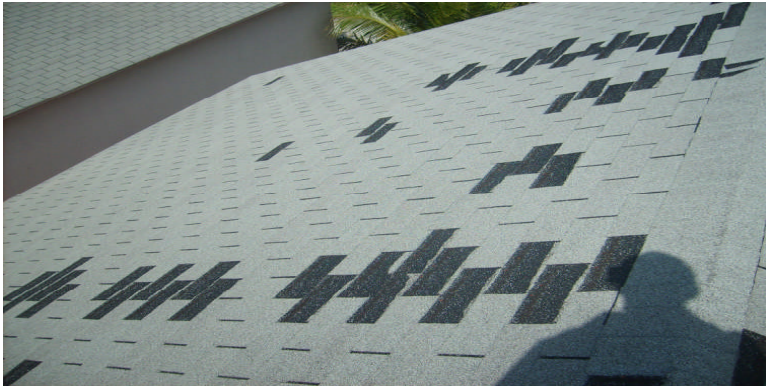
One of the residences used in this study is a 1-story single family home located in the Miami-Dade County with an asphalt shingle roofing system over a plywood roof deck and wood roof trusses. This house was built in 1987. During our post Hurricane Wilma inspection of this roof we found several torn and missing shingles. We also found that the shingles had lost a significant amount of their granules and that black asphalt showed in many places. The observed repairs needed because of the wind damage in this case exceeded 25% of the total roof area. (Photo 6)

Photo 6: Asphalt shingle roofing with wind damage over 25% to the entire roof area.

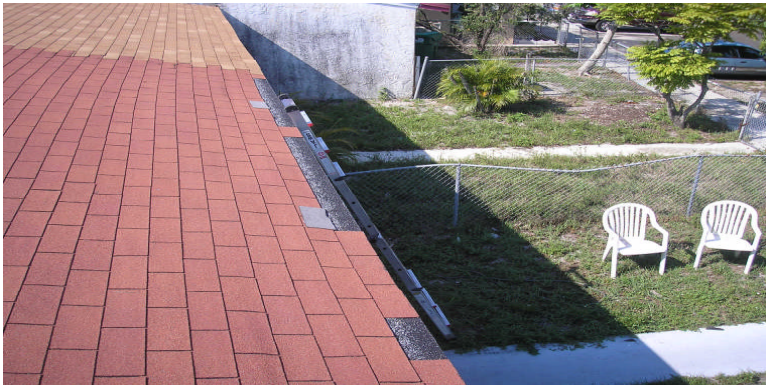
The second residence was also located in the Miami-Dade County. The house is a 1-story single family home with an asphalt shingle roofing system over a plywood roof deck and wood roof trusses. This house was built in 2000. During our post Hurricane Wilma inspection we found a few torn and missing edge shingles. The damage to these shingles was generally consistent with wind damage. The observed repairs needed because of the wind damage in this case were approximately 1% of the total roof area. (Photo 7)

Photo 7: Asphalt shingle roofing with minimal wind damage.

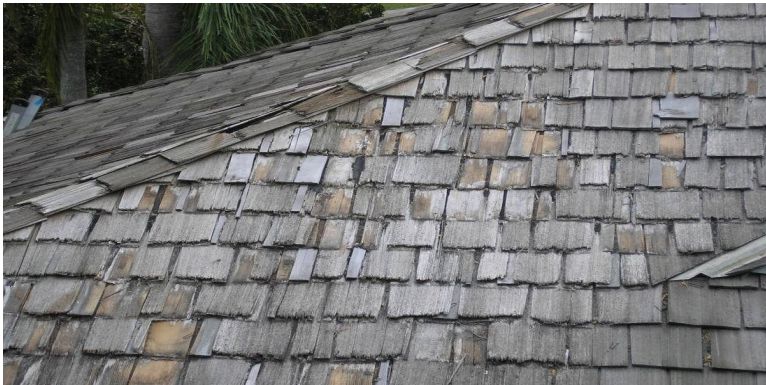
The wood shake roofs inspected had spot locations where the shakes were newly missing or broken. The damage to the shakes at these locations was consistent with wind damage. We also found that the cedar shakes were split, curled and severely deteriorated as a result of long-term exposure. The lower edges of the shakes were splintered, rotted and were easily crushed. This condition was consistent with the age of the shakes and not consistent with damage caused by wind forces. The edges of the shakes at the splits and breaks were severely weathered. This type of roof is rare but not non-existent in South Florida. (Photo 8)

Photo 8: Wood shakes roofing
